Enclave of Naples Condominium Association, Inc.

Structural Integrity Reserve Study

For Period Beginning January 1, 2024

4601 Gulf Shore Boulevard North, Naples, FL, 34103

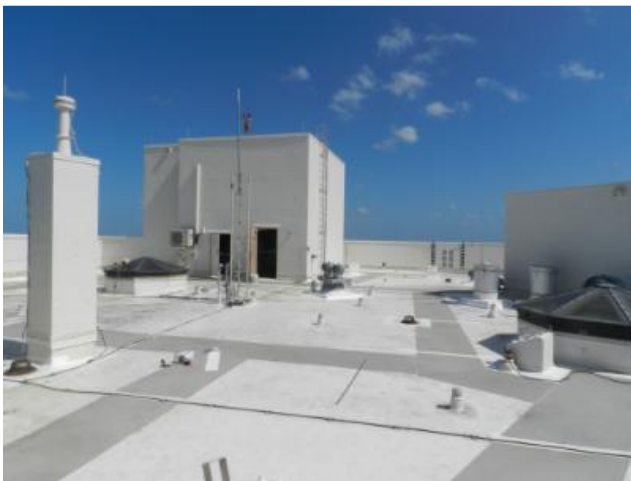
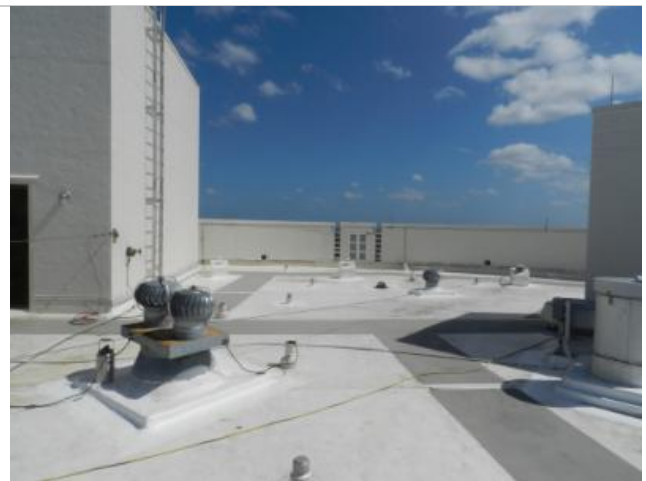
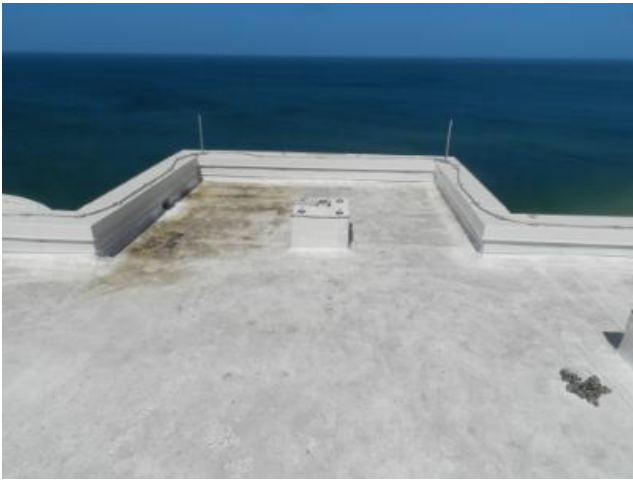
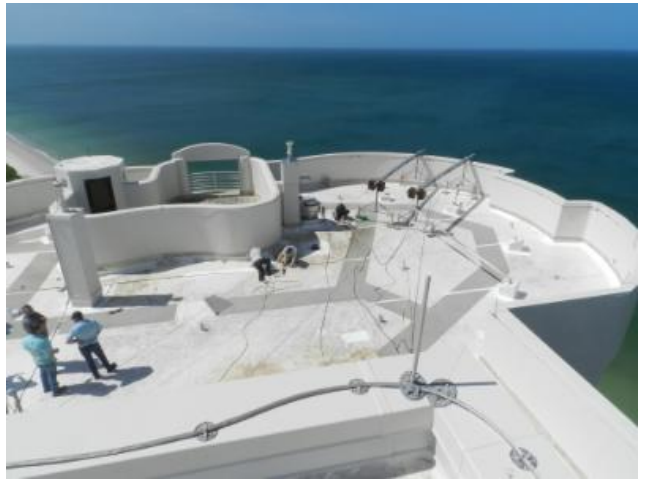
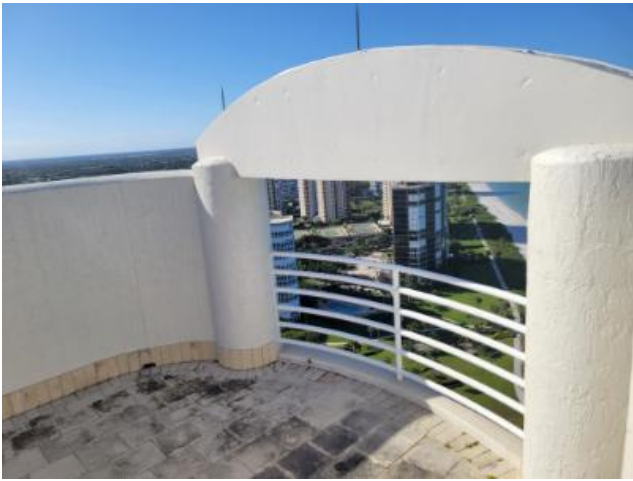
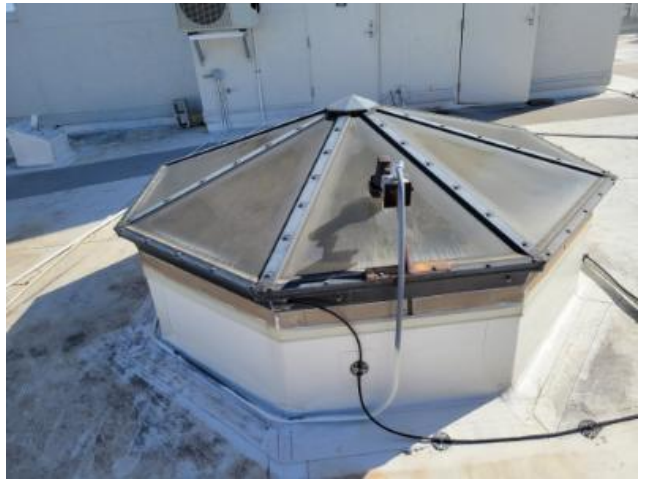
1 - Roof - Tower & Service Area PVC

Type of Cost:	Replacement
Category:	Roof - Tower PVC
Location:	Roof
Regulatory:	SIRS Requirement
Condition:	Good to Fair

Polyvinyl Chlorida (PVC): The condominium tower roof primarily consists of a single ply PVC-membrane system that typically has a useful life of up to 20 years under normal operating conditions. In total, the PVC system covers approximately 7200 square feet of total roof area at the subject site. We understand the PVC membrane was last replaced circa 2016. At the time of our site visit, we observed the PVC membranes to be in good to fair condition for their age. Therefore, we anticipate the roof will require replacement circa 2036. Cost per square foot has increased to \$35 per square foot.

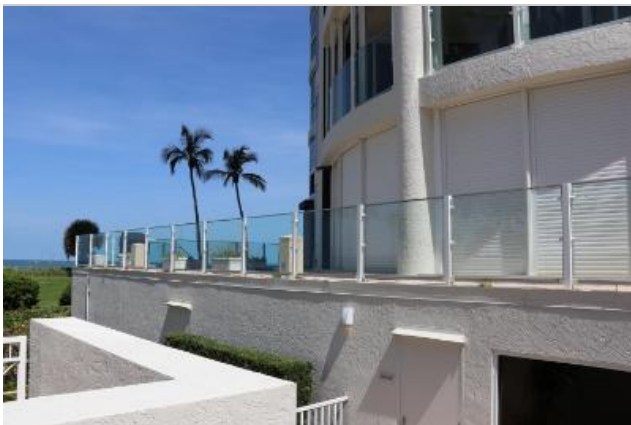
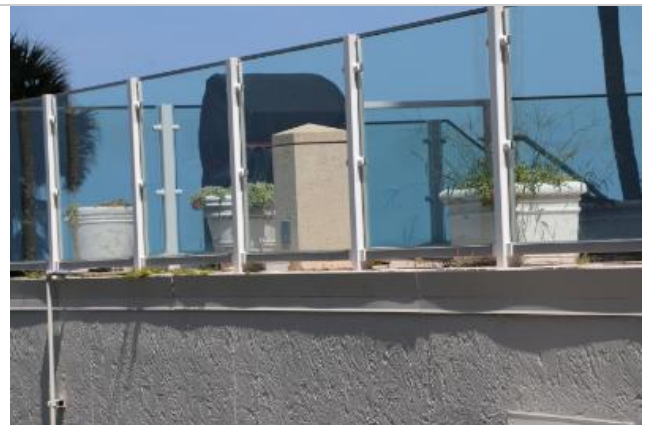
3 - Roof - 1st Floor Terrace - Hydrotech

Type of Cost:	Replacement
Category:	Roof - 1st Floor Terrace - Hydrotech
Location:	Roof - 1st Floor Terrace
Regulatory:	SIRS Requirement
Condition:	Good to Fair

The first floor deck is a hydrotech coating with an estimated 30 year useful life.

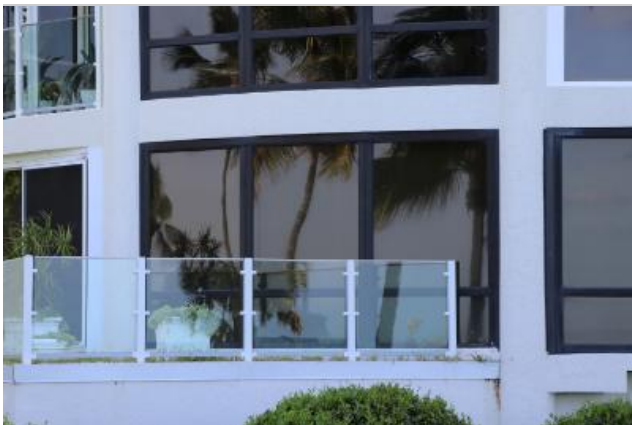
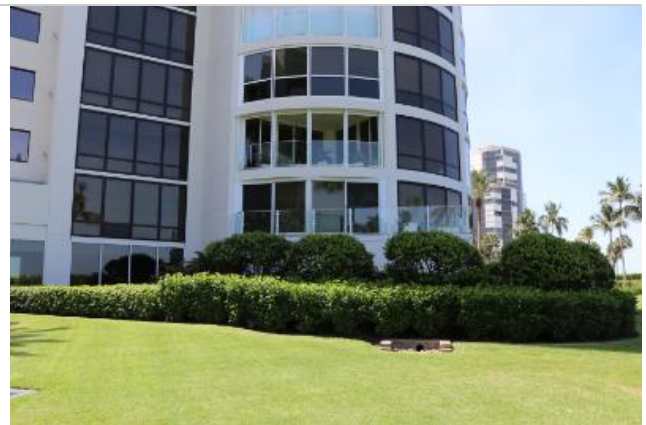
4 - Roof - Unit 1 Terrace - Soprema

Type of Cost:	Replacement
Category:	Roof - Unit 1 Terrace - Soprema
Location:	Roof - Unit 1 Terrace - Soprema
Regulatory:	SIRS Requirement
Condition:	Good to Fair

We understand that these terraces respectively include a Hydrotech and Soprema water barrier system or coating and coinciding concrete paver topping.

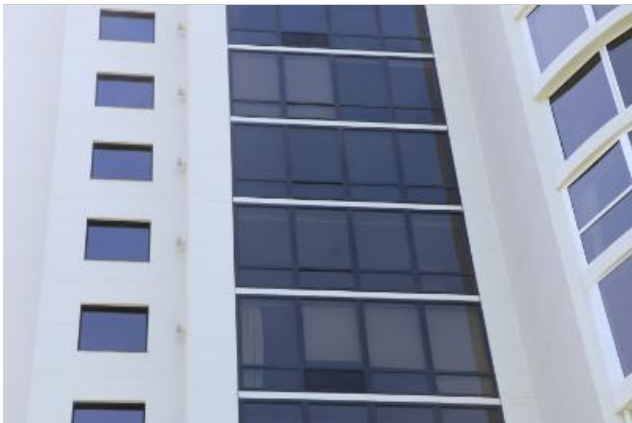
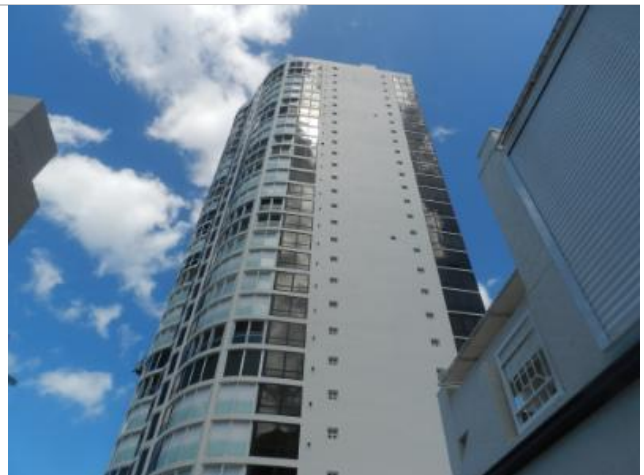
5 - Concrete Restoration W/ Reinforcement

Type of Cost: Repairs & Maintenance
Category: Load Bearing Walls/Structural Members
Location: Entire Building
Regulatory: SIRS Requirement
Condition: Good

Concrete Frame – The load bearing structural members include cast-in-place concrete elements with reinforced concrete, structural decks supported by concrete shear walls, and columns. Exterior walls consist of stucco covered concrete masonry unit (CMU) block in-fill. This type of primary structural members typically has a useful life of 100 or more years when properly maintained/repared. However, during the life of this type of structure it is common for periodic maintenance to be required to correct localized deterioration. We have included a reserve item for completing required periodic maintenance to the cast-in-place concrete structural elements.

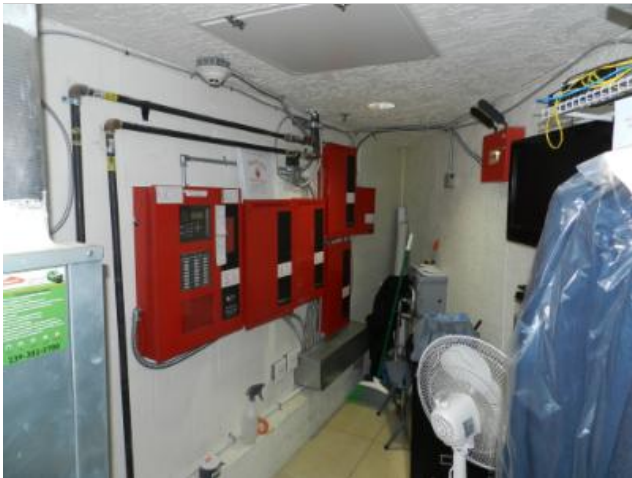
6 - FACP & A/V Fire Alarm System

Type of Cost:	Repairs & Maintenance
Category:	Fireproofing & Fire Protection Systems
Location:	Entire Building
Regulatory:	SIRS Requirement
Condition:	Good

FACP and Audio and Visual Fire Alarm System
- The main fire alarm control panel (FACP) for the condominium is located on the first floor in

the main electrical room. Numerous audio and visual alarms, fire extinguishers, and fire alarm pull switches are located throughout the building. Typically, these control systems have a useful life of 25 to 30 years before requiring an updated system. We understand the fire alarm control panel, the Alarm System, was installed circa 2018. When replacing a fire control panel, typically an update to other various control boxes and visual/audio alarms are required (but not all). Therefore, the reserve has been included for replacement of the FACP and portions of the related equipment.

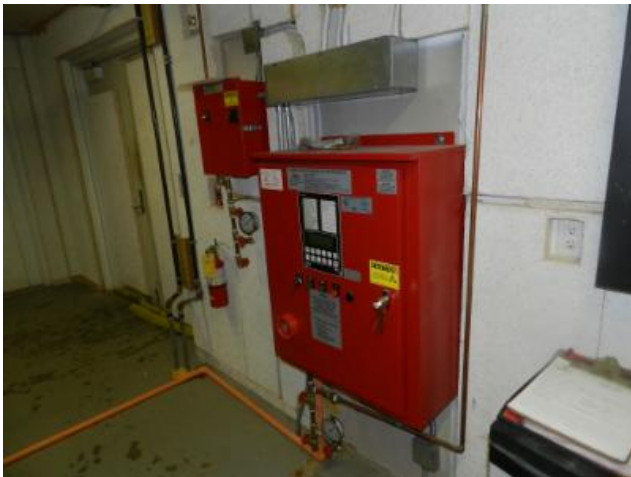
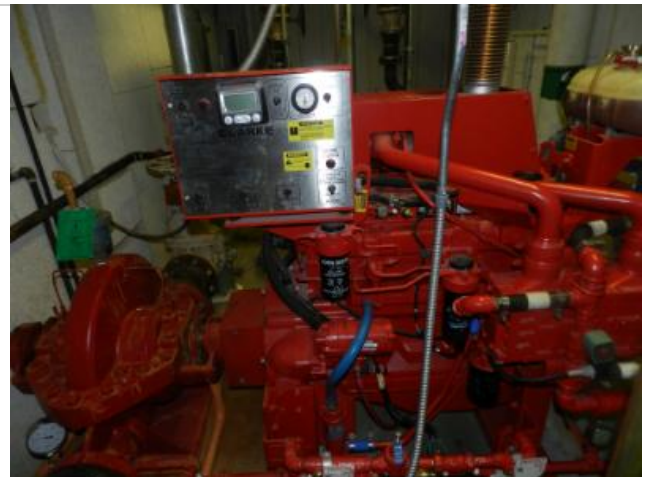
7 - Fire Pump & Controls

Type of Cost:	Replacement
Category:	Fire Mechanical System
Location:	Ground Floor Mechanical Room
Regulatory:	SIRS Requirement
Condition:	Good to Fair

The fire pump and its respective control panel are located in a mechanical room on the main lobby level. Numerous audio and visual alarms, fire extinguishers, and fire alarm pull switches are located throughout the subject site. Typically, these control systems have a useful life of 25-30 years before requiring an updated system. Because the systems were updated circa 2014, we recommend they be scheduled for updating circa 2039.

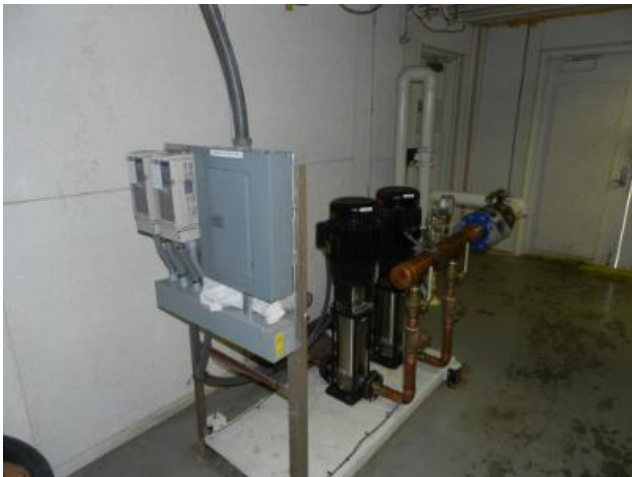
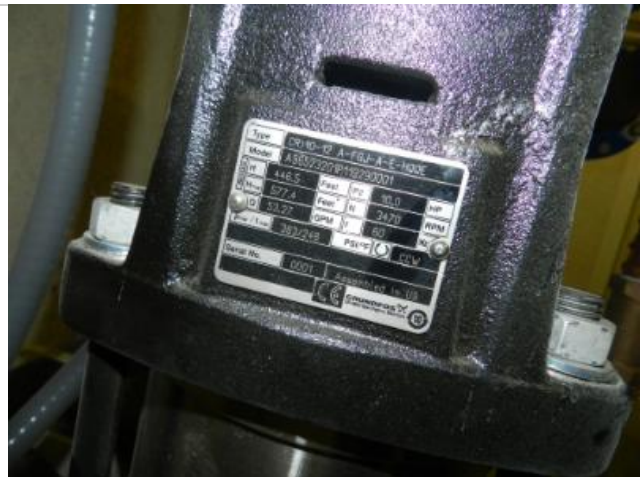
9 - Plumbing - Domestic Water Pumps & Controls

Type of Cost:	Replacement
Category:	Plumbing
Location:	Lobby - Mechanical Room
Regulatory:	SIRS Requirement
Condition:	Good to Fair

The domestic water pumps and control system for the condominium in a mechanical room located on the lobby level of the condominium. These components are typically replaced in tandem and can achieve a useful between 20-25 years. We understand the pumps and control systems are currently scheduled for replacement circa 2039. This element includes two-pumps, and respective variable frequency drives and control system.

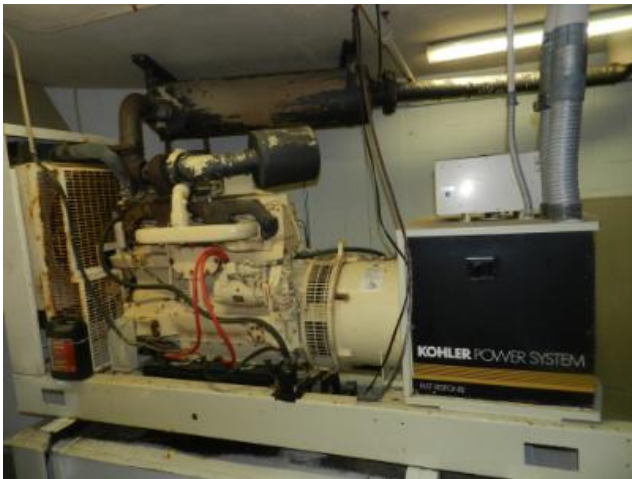
11 - Emergency Generator

Type of Cost:	Replacement
Category:	Electrical
Location:	Generator Room
Regulatory:	SIRS Requirement
Condition:	Good

This building includes a backup generator located in a mechanical room on the ground floor of the condominium. We estimate a typical useful life of 30-35 years with regular maintenance performed. The costs associated with this category include the main generator unit and other system components. We added 6 years of life and increased the date to 2041 given the work done on the generator and replacement of the transfer switch.

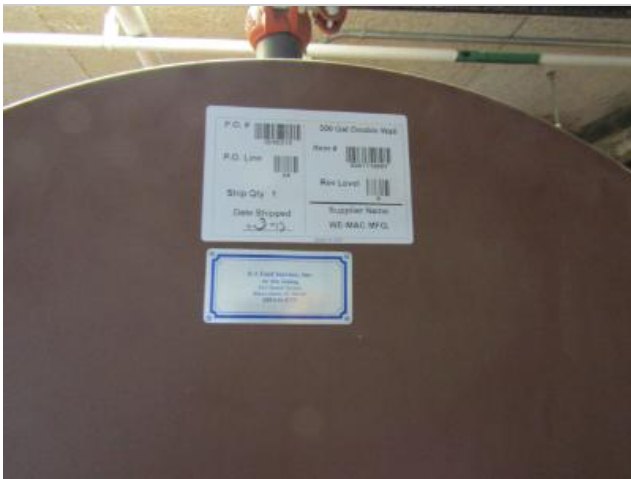
12 - Diesel Fuel Tank

Type of Cost: Replacement
Category: Electrical Mechanical System
Location: Fire Pump Room
Regulatory: SIRS Requirement
Condition: Good to Fair

Diesel Fuel Tank inspected and in good to fair condition.

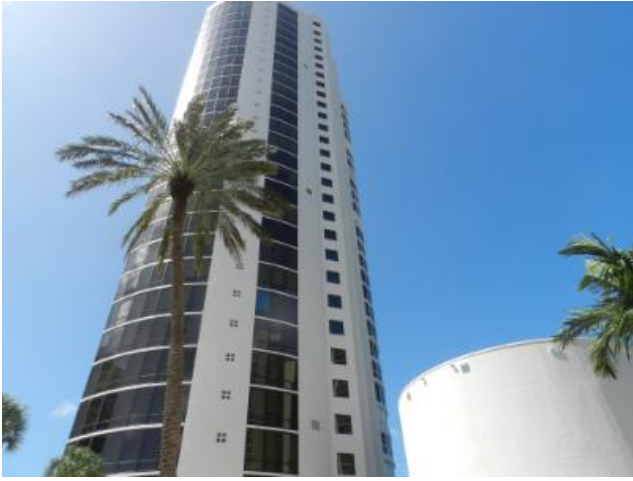
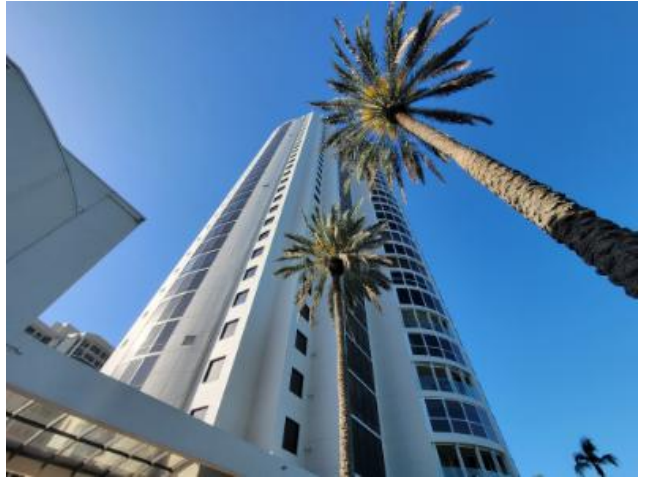
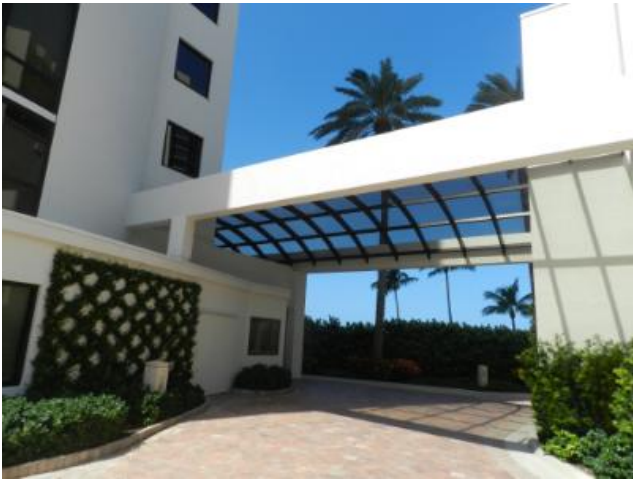
13 - Paint - Exterior Tower Paint, Seal, Repair Stucco

Type of Cost:	Repairs & Maintenance
Category:	Waterproofing and Exterior Painting
Location:	Entire Building
Regulatory:	SIRS Requirement
Condition:	Good to Fair

Exterior Paint—The Association is responsible for maintaining, repairing, and recoating the exteriors of the condominium in addition to cleaning and sealing all exterior joints and other components. We understand the building was last recoated in 2020. The existing paint was observed to be in good overall condition. For buildings located near the Gulf of Mexico in the Southwest Florida region, we recommend the exteriors be recoated on a 7-year basis. Therefore, the building will likely require an additional coating circa 2027.

Exterior Restoration – During the recoating of a building, it is typical to find distressed stucco and exterior sealants. A reserve has been included for periodic repairs/restoration of the buildings' exterior envelope components including sealants and stucco repairs. The reserve is based on an 7-year cycle to coincide with every exterior re-coating project. Note: Window Sealants have a 14 year useful life.

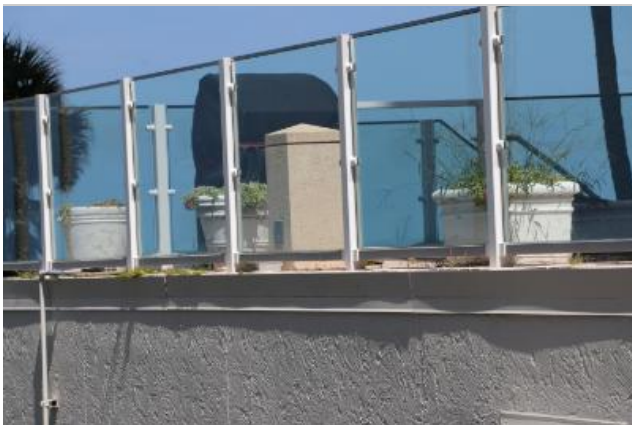
Type of Cost:	Repairs & Maintenance
Category:	Common Area
Location:	Entire Building
Regulatory:	SIRS Requirement
Condition:	Fair

Common Area railings have been replaced with glass guardrail systems with a 30-35 year life in 2022.
